# TOTAL FIRE GROUP LTD

## Fire Risk Assessment

Village 135  
3 Hollyhedge Court Road  
Wythenshawe  
Manchester  
M22 4GW

29 January 2024

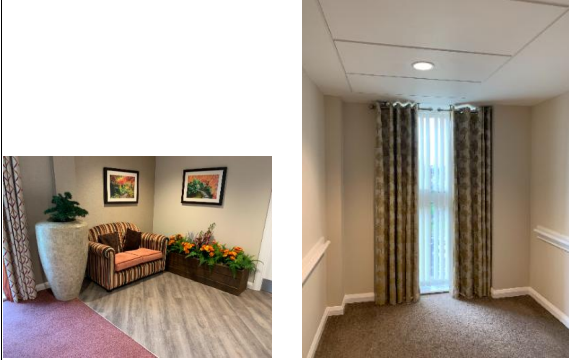
5.2

<p>Some artificial plants and curtains were seen in various locations including at the end of and in the corners of corridors, however certification dated 06/2019 was provided to our assessor which evidenced that samples of these had been tested by 'Greenplants Group Ltd' which evidenced that each sample met the requirements for Type B performance in BS5867-2:2008.</p>

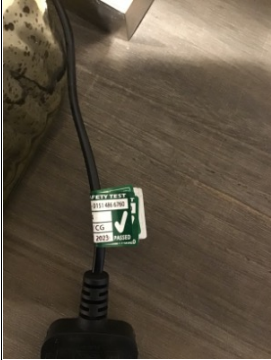
6.5

<p>It was noted that Portable Appliance Testing (PAT) is regularly carried out on an annual basis as organised by Wythenshawe Community Housing Group. Test labels on some appliances indicated testing was last carried out during April 2023. It is highlighted that not all electrical devices need to be the subject of an annual portable appliance test (PAT). The Health and Safety Executive (HSE) advocates a proportionate, risk-based approach to the maintenance of portable electrical appliances within the workplace. This guidance is simple and easy to follow and can be found on the HSE website "Maintaining Portable Electrical Equipment in a low risk environment".</p>

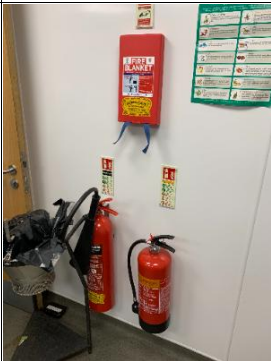
6.19

<p>As previously indicated CO2, a fire blanket, and wet chemical firefighting equipment is provided in the kitchen of the Hub.</p>

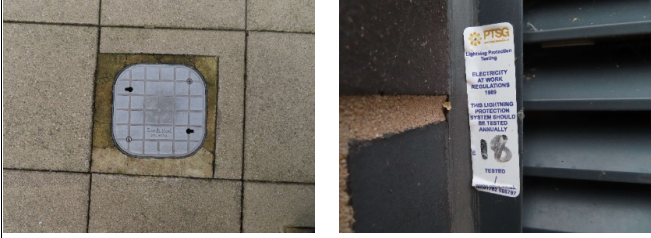
6.21

<p>The lightning protection systems are maintained and serviced periodically by PTSG. Records are held electronically on WCHG internal systems.</p>		
6.22	<p>At the time of this fire risk assessment, no other sources of heat, such as (e.g. candles, cigarettes or unauthorised domestic appliances) were seen within the common areas and there are no solar panel systems installed on this site.</p>

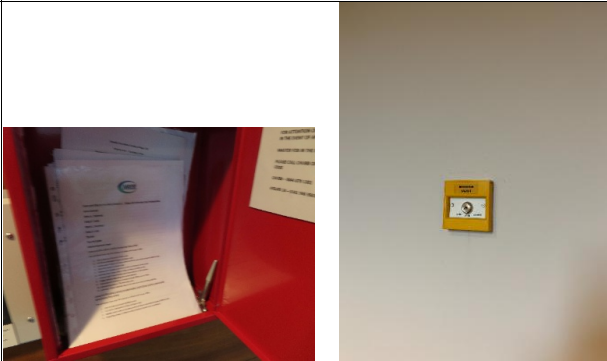
8.2

<p>It has been confirmed and evidence was seen that the windows at the end of the residential corridors are provided with manually openable locks/catches which can be opened if required by the Fire Service. The T Key that enables this process is located in the SIB, located in the entrance foyers, for use by fire crews.</p>

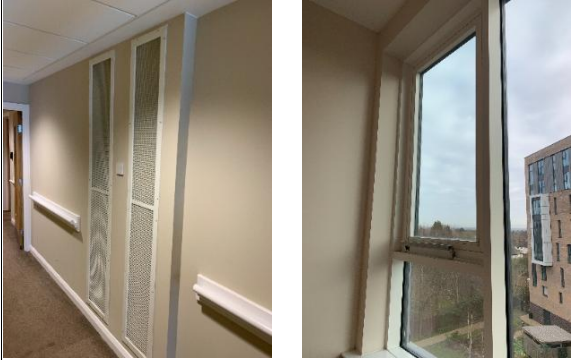
8.2

<p>Staircases are provided with Automatic Opening Vents (AOVs) at their head, which are tested weekly by maintenance staff and serviced every six months by Dyer Environmental Controls Ltd. Corridors are provided with either AOV windows at their end or, where landlocked, smoke shafts which are linked to the fire alarm and which are also tested and serviced. Certain corridors on the ground floor were observed to have manually openable windows provided as opposed to AOVs.</p>

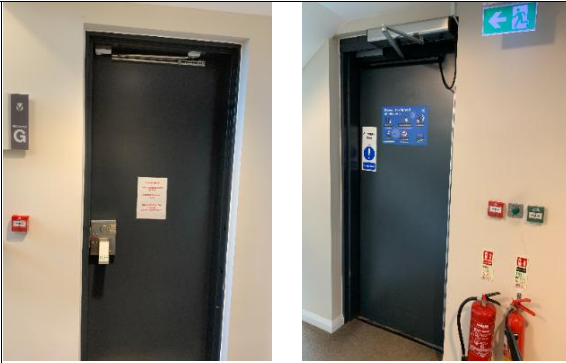
8.11, 8.13

Final exits from the building are, in the majority, either electromagnetically secured with a suitable override or provided with push pad type opening devices.

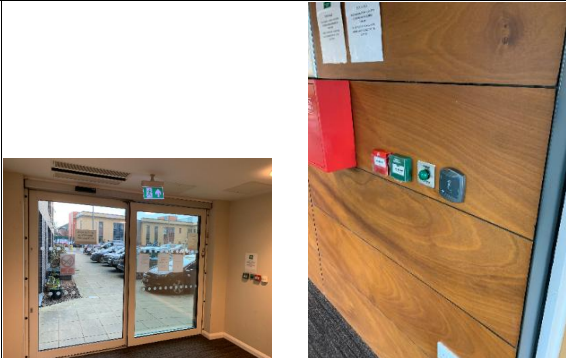
8.11, 8.18-8.19

Certain final exit doors are provided with a sliding power assisted opening mechanism. Assurance was provided that these are linked to the fire alarm and open upon its activation. A 'Green Box' emergency override is also installed adjacent to the doors and opens the doors when activated.

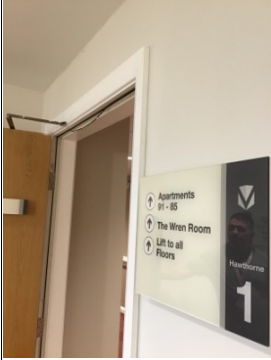
9.5	Arrange for a competent person to secure the metal fixing and ensure the door closes fully.
	<b>Observation</b>
9.6	The 1st floor staircase door in Hawthorn has a damaged and part missing smoke seal. In the event of a fire smoke may enter the escape staircase placing relevant persons at risk of harm.

9.6	Arrange for a competent person to replace the smoke seal and ensure the fire door closes fully.
	<b>Observation</b>
9.6	The cross corridor fire doors indicated on the plan have an excessive gap that may allow smoke to spread along the corridor which may place relevant persons at risk of harm in the event of a fire.

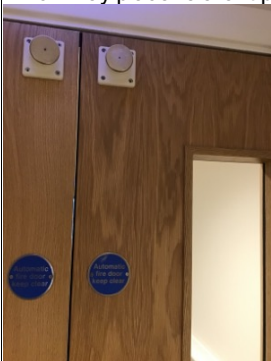
9.6	Arrange for a competent person to adjust the seals/door to ensure a suitable smoke seal is maintained.
	<b>Observation</b>
9.6	The cross corridor fire doors indicated on the plan have an excessive gap that may allow smoke to spread along the corridor which may place relevant persons at risk of harm in the event of a fire.

9.6	Arrange for a competent person to adjust the seals/door to ensure a suitable smoke seal is maintained.
	<b>Observation</b>
9.6	The cross corridor fire doors indicated on the plan have an excessive gap that may allow smoke to spread along the corridor which may place relevant persons at risk of harm in the event of a fire.
	<b>Recommended Actions</b>

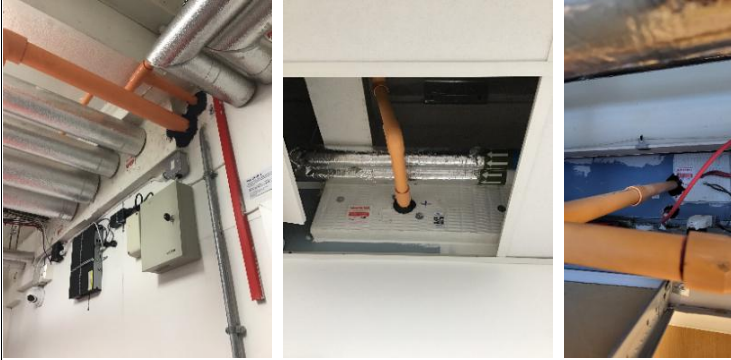
9.1, 9.8

<p>Galliford Try (GT) and Tenos have been working closely for an extended period of time in order to carry out a type 4 compartmentation and fire stopping survey throughout the premises. There have been a number of surveys carried out since the construction was finished in 2017 with the latest carried out by Tenos, following which it was identified that a full building survey was required. This has been carried out by GT, with GT applying the fire stopping works where any breaches or deficiencies are identified. Our assessor was informed that this work is mostly complete, however there are still some areas that are opened up with necessary works being finalised. A fire stopping certificate/statement is to be issued on completion together with the information recorded electronically of locations and materials used for ongoing maintenance and inspection.</p>

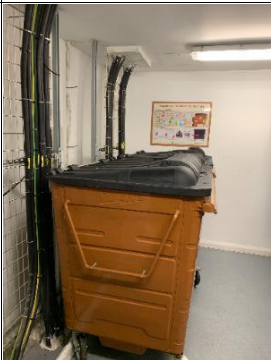
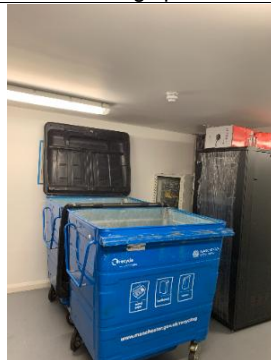
</div> <p>Waste bins are stored internally in specified refuse rooms which are lobby separated from corridor escape routes.</p>

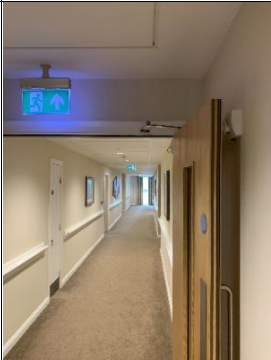
9.25	<div style="display: flex; justify-content: space-around;">

</div> <p>Electromagnetic corridor doors held open on auto door release devices are not released at night, to allow the free movement of the residents, but the doors are routinely tested and are linked to the fire alarm system. Detectors were seen to be in place in close proximity to the doors on the corridors.</p>

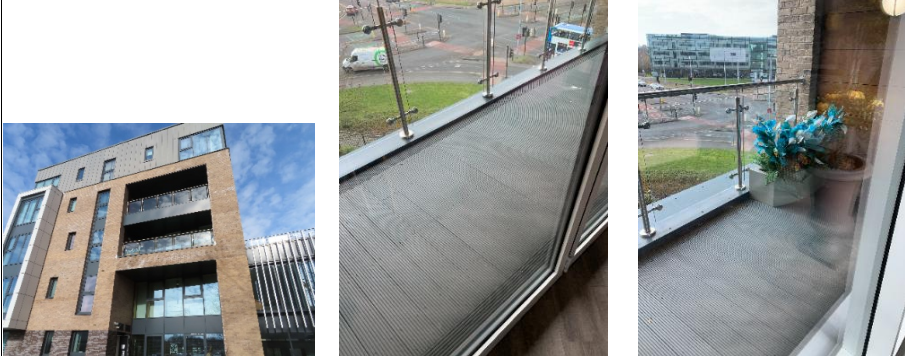
<p>It was noted that there are two balconies on the Cedar block, adjacent to the roof top garden area, but it was made clear that the use of these is controlled by the premises management team and access is only allowed at certain times. Residents do not have general access to these areas. No sources of ignition are allowed on these areas and the storage of combustibles on the balconies is closely controlled, with access through the patio doors opening onto the balcony also controlled.</p>
<p>9.27</p>	<p>The risk of external fire spread should be considered as part of the fire risk assessment for these buildings. The fire risk assessment should take into account a number of factors other than height and material type, including the vulnerability of residents, location of escape routes, and the complexity of the building.</p> <p>Whilst materials used on residential buildings with a top storey below 18m may be deemed to comply, the original design fire strategy indicated a "Stay Put" strategy was to be the basis for the building design. Previous findings regarding the cladding systems used indicated that there was a likelihood that the external wall may assist in fire spread that was likely to affect more than one apartment. The "Stay Put" strategy is predicated on the assumption that an outbreak of fire in an apartment should be contained and other neighbouring residents are safe to remain in their apartments. Until such time as sign off is provided by the specialist external wall contractors and consultants, the current building simultaneous evacuation procedure on 2nd knock mitigates against external fire spread ensuring persons are warned of fire and need to evacuate at the earliest opportunity.</p> <p>Remedial actions may be required in the buildings below 18m formerly deemed to comply with the Building Regulations where there is a risk to the health and safety of residents. With regard to the current interim simultaneous evacuation procedure, the following is assessed:</p> <ul style="list-style-type: none"> <li>• The vulnerability of residents - There is a range of abilities amongst the residents from those who are fit and able to self-evacuate to ones who need substantial assistance from staff.</li> <li>• Location of escape routes - These are relatively simple and straightforward with stairs provided with disabled refuge points and communications systems. A fire spreading externally is unlikely to affect more than one exit staircase in the early stages of a fire and prior to the arrival of the Fire and Rescue Service. A fire is unlikely to spread internally due to the sprinklers and compartmentation, particularly following impending completion of the type 4 compartmentation and fire stopping work.</li> <li>• The complexity of the building - The layout of the common escape routes from apartment entrance doors provide for two directions of escape with several intermediate areas of relative safety which allow for extended evacuation times.</li> </ul> <p>Note: Village 135 is unlike a high rise residential tower block in that staff are present 24 hours a day. A comprehensive fire detection and warning system linked to staff handsets and an off-site alarm receiving centre (ARC) is installed throughout which provides an immediate indication for staff to respond in accordance with the latest fire strategy. All apartments have been fitted with common fire alarm sounders to provide the requisite sound levels within each apartment.</p>

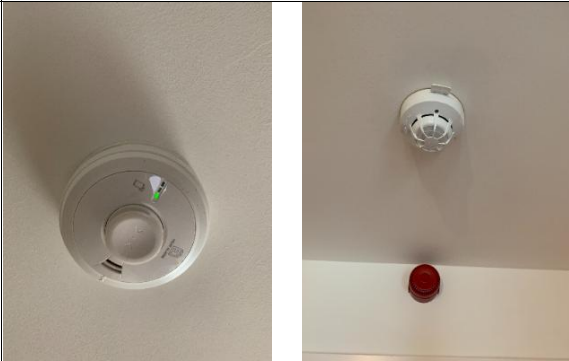
<p>The system now installed within each apartment appears to conform to BS 5839-6 to at least Grade D, category LD1 standard, with multi-sensor detectors installed in all habitable rooms except the kitchen area, where a heat detector is provided. The systems are linked to the 'Dect' care call phones with each member of care staff carrying a receiver and call point in the reception/office.</p> <p>A fully addressable BS 5839-1 fire detection and warning system is installed within the common areas, which appears to be to a minimum of L2 standard, with a linked heat detector and separate sounder located in the hallway of each flat. The automatic fire detection and warning system installed in the common areas sounds an alarm to initiate a simultaneous evacuation of all the common areas within the individual block of activation.</p>

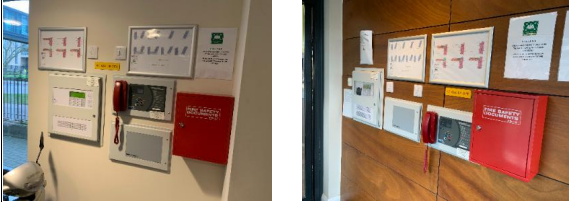
10.1, 10.13

<p>Fire alarm panels are provided in the entrance foyer to the Hub and the entrance foyer to Block C. A repeater panel is provided by the ground floor corridor exit from Block A. Suitable fire alarm zone plans are provided adjacent to each alarm panel in the blocks, with the exception of the repeater panel in Block A.</p>

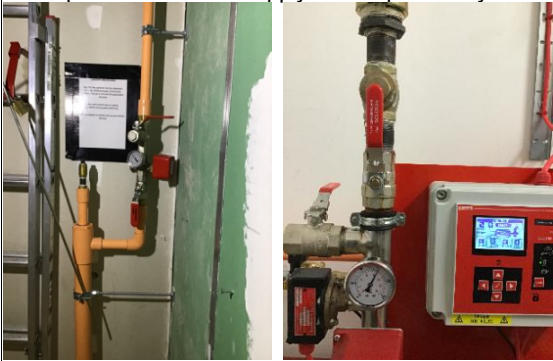
12.8	<p>Sprinkler stop valves are not locked in the open position. Whilst it is acknowledged the valves are located in lockable risers/rooms and access is provided by building maintenance team to these areas, there is a risk of accidental or deliberate interruption of the water supply to the sprinkler system by persons accessing these areas. See commentary 12.8.</p>

12.8	The Responsible Person should contact the sprinkler contractor (Argus) to arrange for the stop valves to be locked in the open position. Keys should be clearly identified and readily available for the Fire and Rescue Service in order to isolate a zone or the system in the event of activation or following a fire incident.
	<b>Observation</b>

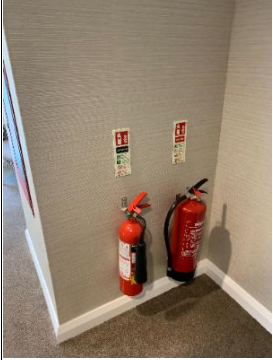
<p>Portable firefighting equipment would not be generally sited in the corridors to flats as this may pose a risk to residents leaving their flat on fire and returning with a fire extinguisher, placing them at increased risk as they are not trained. However, the premises are staffed 24 hours a day, with trained staff responding to any fire alarm and the current availability of fire fighting equipment is considered suitable. The accommodation area extinguishers are generally sited in stairwells and not in the immediate vicinity of flat entrance doors. The firefighting equipment is in the form of water (or foam) and CO2 stations throughout. Such extinguisher points are also provided in higher risk areas such as refuse rooms, electrical rooms and the like.</p>

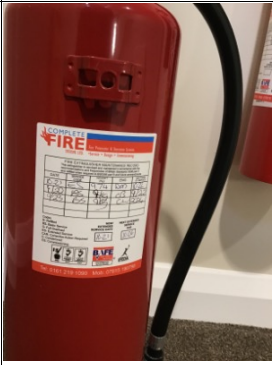
12.4-12.5

<p>Monthly visual checks of firefighting equipment are undertaken, with records held digitally by WCHG. The firefighting is also serviced annually by a competent person, with this last having been carried out in 09/2023.</p>

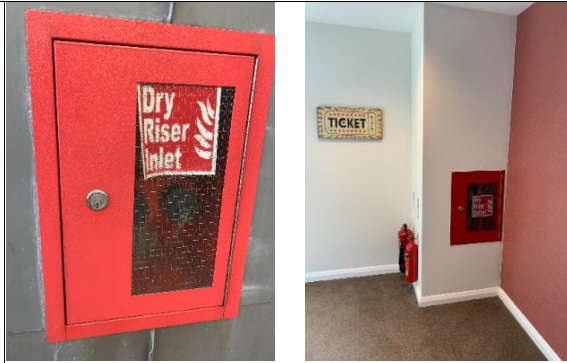
12.10

Firefighter dry rising mains are located in each block, so as to provide a firefighting facility due to the size and layout of the blocks. The inlets are located on the external façade and the outlets are located at each level of one of the staircases per block. The dry rising mains are subject to periodic service and inspection by a competent person, with records held centrally by WCHG.

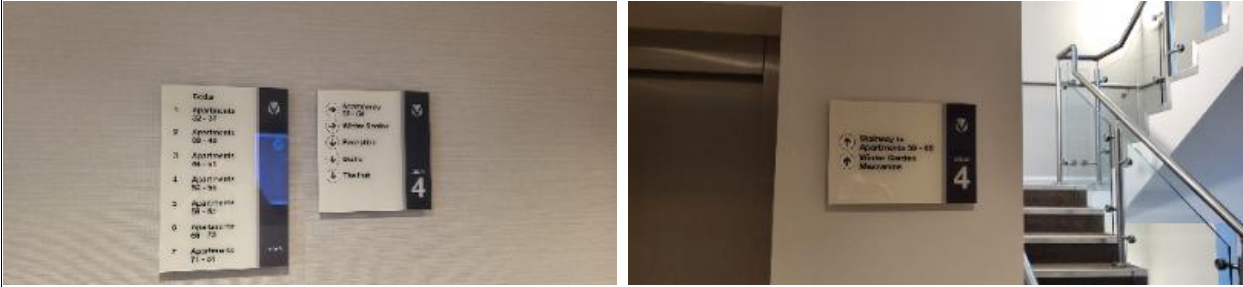
<p>Although in Block B wayfinding signage does not strictly conform to the standards outlined in Approved Document B, signage was observed at each floor level opposite the lift and by the stairs which clearly detailed each level which apartments were on said level and the direction to them. The secondary staircase has similar signage. The Fire safety England Regulations 2022 require signage to be installed by law in all existing high-rise buildings of 7 or more storeys or with a top floor height above 18m.</p>
	<b>Recommended Actions</b>

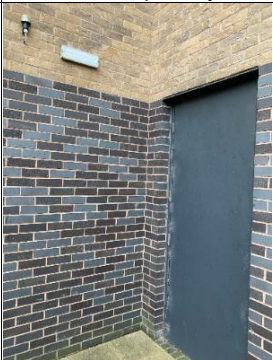
13.10

<p>Although not all fire exits have 'Fire Exit Keep Clear' signage affixed to the external side, those that do not are not at risk of being blocked due to these being set back from areas where blockage could occur (e.g. on raised pavement areas). No blockage of these exits was observed at the time of this fire risk assessment.</p>

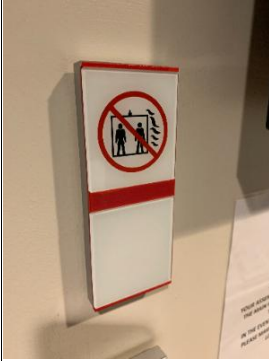
13.10

Suitable 'Do Not Use in the Event of Fire' signage was provided adjacent to the lifts.

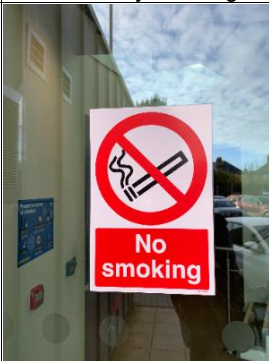
13.12

"No Smoking" signs are displayed as required by The Smoke Free (Premises and Enforcement) Regulations 2006. The only smoking allowed is within the resident's own flats. There is no smoking allowed within any communal area or circulation space.
