TOTAL FIRE GROUP LTD

Fire Risk Assessment

Birch Tree Court Rowlandsway Wythenshawe M22 5SL

06 June 2023

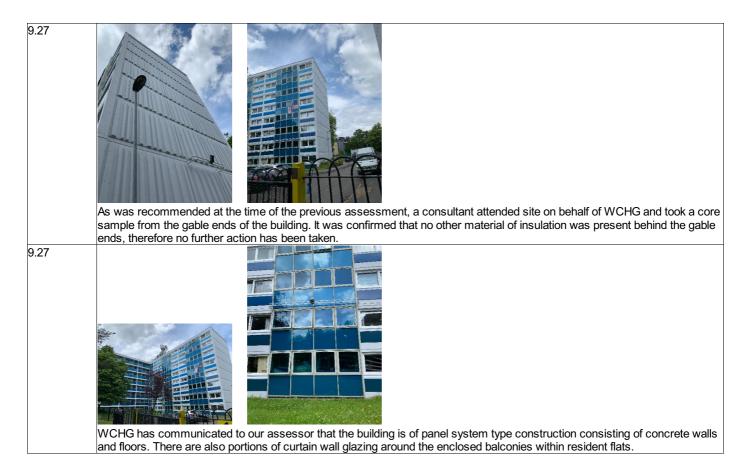
9.8	Although there are corroded intumescent collars passing through the ceilings of the riser cupboards on the seventh floor, this building has a flat roof. Unless it is determined that there is a void or other such space for a fire to spread into above the seventh floor riser shafts, these collars would not require replacement.

9.18	CCTV is provided in the common areas.
9.27	WCHG have informed our assessor that following an inspection by Tenos Ltd, the panels of the balustrades to the balconies that provide access to the flats have been identified as being of high-pressure laminate (HPL) construction. WCHG have received confirmation from Tenos Ltd that these panels are of an acceptable standard to be used in this location. Previous fire risk assessments have also confirmed that remedial works have been carried out to curtain wall systems, following recommendations from the report compiled by Tenos Ltd. The curtain wall systems have been confirmed to comply with building regulations in their current state.
