TOTAL FIRE GROUP LTD

Fire Risk Assessment

1-87 Edwards Court
Rowlandsway
Wythenshawe
M22 5SE

04 June 2024

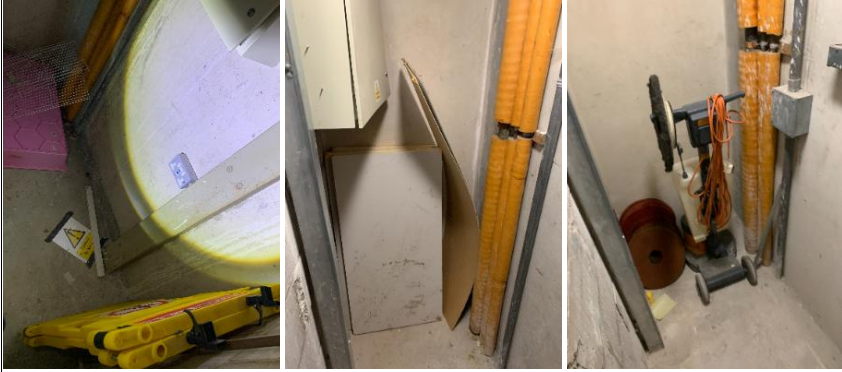
9.16	<p>Observation</p> <p>As highlighted in the previous fire risk assessment, storage was observed in the room containing electrical equipment adjoining the bin chute room on the second floor, third floor and seventh floor. Where combustibles are located in close proximity to a source of ignition there is increased potential for a fire to begin and develop, placing persons at risk of harm.</p>

9.16	<p>Recommended Actions</p> <p>It is recommended that the storage is removed or adequately separated from electrical ignition sources.</p>

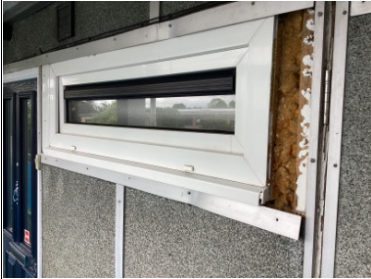
9.1, 9.8	<p>At the time of the fire risk assessment, it was observed that a part of the window frame on flat 45 had been removed.</p>

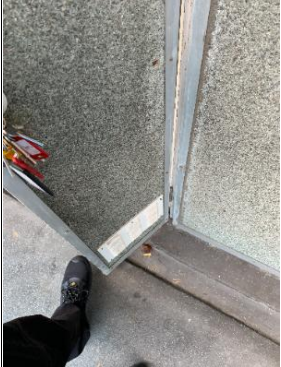
Observation	
9.1, 9.8	<p>It was highlighted in the previous fire risk assessment that in the riser cupboards adjoining the open deck, metal grilles are located in the lower portion of doors. When shining a torch through the grille, the previous assessor was able to view the light passing through. It should be noted that the cupboards are fitted with robust doors with adequate intumescent strips and smoke seals and are kept locked shut. The building is operating on a stay-put strategy, flats have sprinkler protection and nearly all flats have deck access. Also, some of the low-level vents observed did not appear to have holes through the door.</p>

Recommended Actions	
9.1, 9.8	<p>Property protection: It is recommended that the low-level vents that contain the electrical units and TV aerial splitters and cables be sealed.</p>

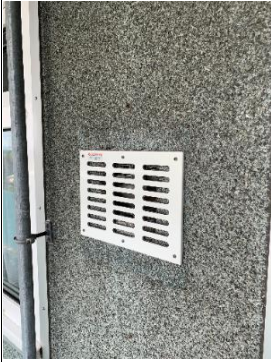
Ref	COMMENTARY
9.0	Within the resident flats, the doors to the living room and kitchen are notional fire doors.
9.1	<p>Service risers adjacent to flats are provided with high-level intumescent grilles. Although these will not seal in the early stages of a potential fire, therefore enabling passage of smoke and other products of combustion, the flats are accessed via open deck therefore this is considered acceptable. The grilles are also above 1.1m in height.</p>

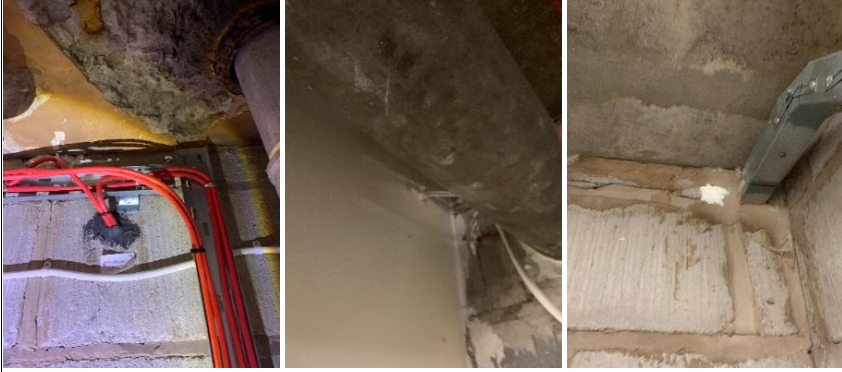
9.1, 9.8	<p>The previous fire risk assessment raised an action that there were multiple breaches in fire-resisting construction.</p> <ul style="list-style-type: none"> • The breach at the back of the dry riser cupboard on the seventh floor, leading horizontally has been fire-stopped. • The breach in the sixth-floor room adjoining the bin chute room has been fire-stopped. • The small hole in the electrical room wall at the top (third floor) has been fire-stopped.

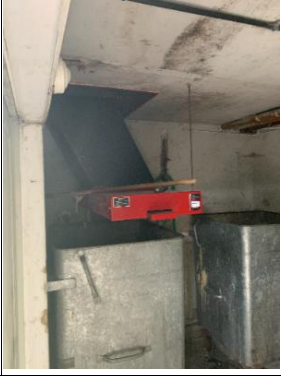
9.16	<p>In the bin room on the ground floor, the bin in use is located adjacent to a lid that has a fusible link which enables the lid to self-close over the bin should a fire occur. This is to prevent the fire, smoke and toxic gases from spreading up the chute. The fusible link is checked annually by an appointed contractor. The photographs above show the lid and an example of the bin hoppers located on each floor, which are metal in construction and are self-closing with rubber seals. Both the main bin room and the chute rooms are provided with a means of ventilation.</p>

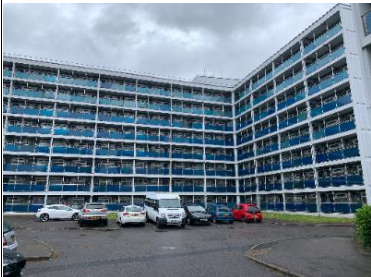
9.27	<p>WCHG has communicated to our assessor that the building is of panel system-type construction consisting of concrete walls and floors. There are also portions of curtain wall glazing around the enclosed balconies within resident flats.</p>

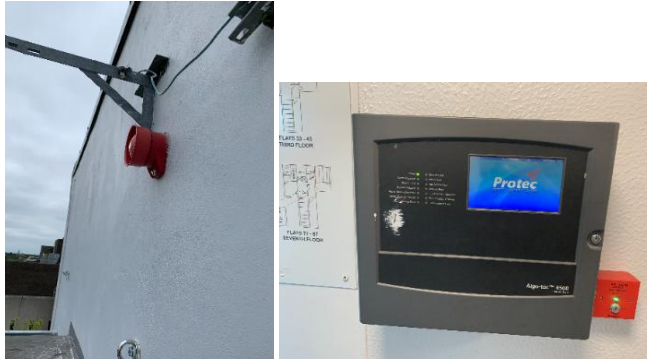
Ref	COMMENTARY
10.3	WCHG have confirmed that detectors in flats are checked and the findings recorded as part of the annual gas servicing.
10.6	<p>The common area fire alarm and detection system incorporates smoke detection throughout commonly used areas and heat detection in the hallways of each resident flat. The fire alarm panel for the system is located in the lift lobby at the ground floor level and appeared healthy at the time of the assessment. It was previously confirmed to our assessor that the system is addressable. It has been previously confirmed to our assessor that, although the common fire alarm system is silent through the majority of the premises, it is audible in plant and service areas, including on the roof where a sounder is present.</p>

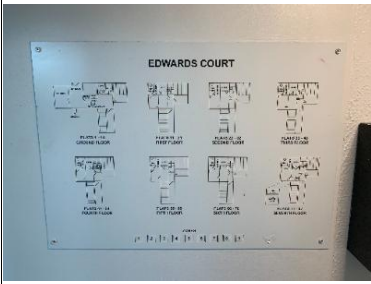
10.13	<p>A suitable building and zone plan is provided adjacent to the fire alarm panel on the ground floor.</p>

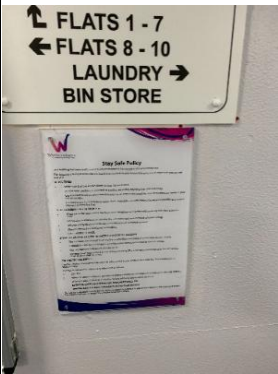
13.6	<p>The previous fire risk assessment recommended that a fire action notice be provided in the common area, clearly detailing the evacuation strategy for the building and the action required of residents in the event of a fire. At the time of the fire risk assessment this action had been completed.</p>

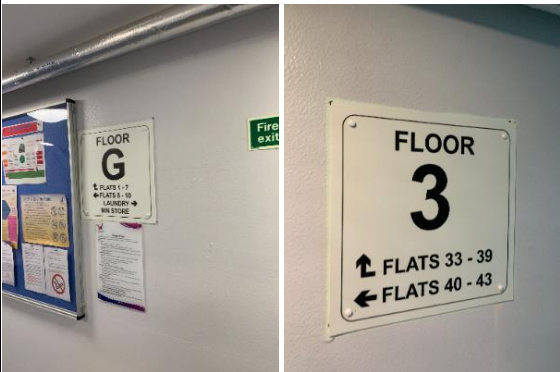
13.12	Suitable 'No Smoking' signage was observed in the common area.
13.15-13.16	Wayfinding signage that has the floor number and directional signage to the flats, including flat numbers, is now displayed in the lift lobbies and on the stairway landings.

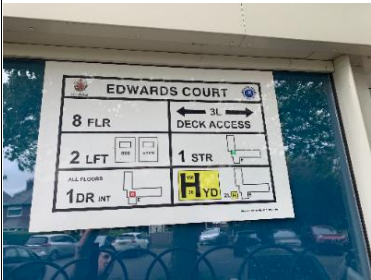
14.11	The Fire Service has been provided with access fobs for all WCHG high rise blocks.
14.11	Signage indicating certain provisions of the building is displayed externally, which may be used to assist attending Fire and Rescue Service personnel.
