TOTAL FIRE GROUP LTD

Fire Risk Assessment

West View Court
West View Road
Wythenshawe
Manchester
M22 4LQ

30 May 2024

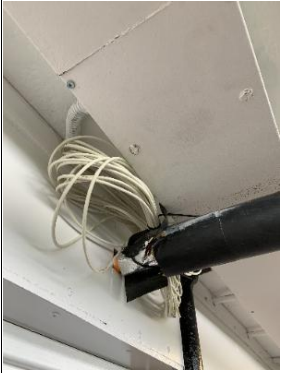
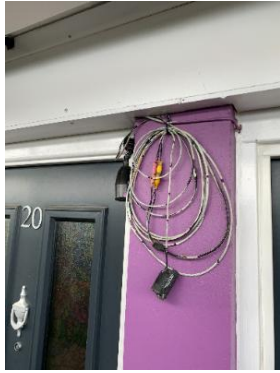
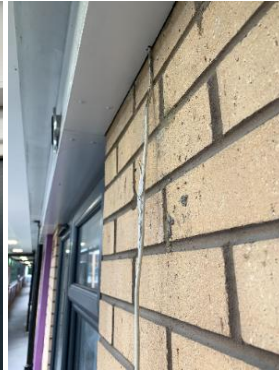
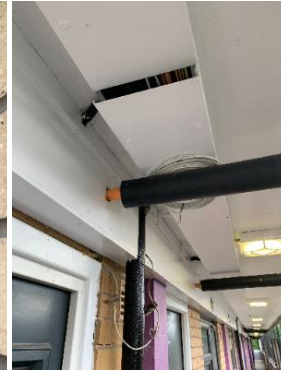
Ref	SIGNIFICANT FINDINGS
	None.
Ref	RECOMMENDATIONS
	Observation
6.14	<p>On some of the open decks, cables which appear to have previously been cable-tied have come loose and droop over the decks.</p> <div style="display: flex; justify-content: space-around;">

</div>
	Recommended Actions
6.14	Cables which have become unaffixed over the open deck should be re-affixed.

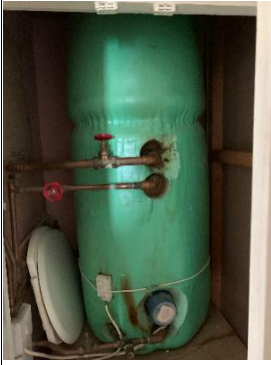
6.20	<p>WCHG have confirmed to TFG that gas boiler systems are on an annual servicing programme with a competent contractor, with records to evidence this practice held centrally by WCHG. Heating vessels are provided to individual flats.</p>

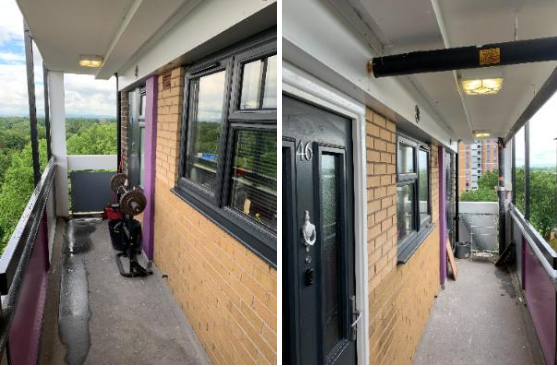
Ref	SIGNIFICANT FINDINGS
	Observation
8.7	<p>As highlighted in the previous fire risk assessment there were combustibles/items stored within the communal area, that would provide fuel for a fire and they are also an obstruction/trip hazard for persons evacuating the premises and for the fire service attending an incident. Items left in the common areas place persons at risk of harm.</p> <div style="display: flex; justify-content: space-around;">

</div>
	Recommended Actions
8.7	WCHG should continue to manage the storage, including removals, in line with their policy. Residents should be reminded to not store personal items or refuse in the communal areas.
Ref	RECOMMENDATIONS
	None.

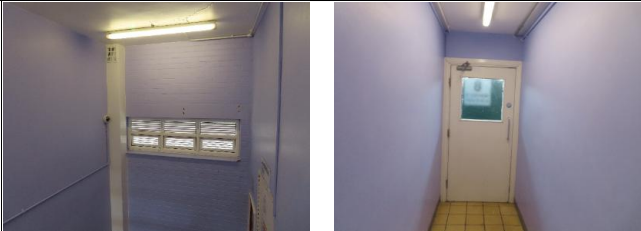
8.2

Smoke ventilation in the stairway is provided by permanently open vents (POVs) on each stair half landing. These vents together provide an area in excess of the 1m ² required. In addition, the doorway from the stairway onto the uppermost open walkway can be opened for additional ventilation if required. This arrangement is considered acceptable by our assessor, after taking into account the layout of the premises and the open deck access.

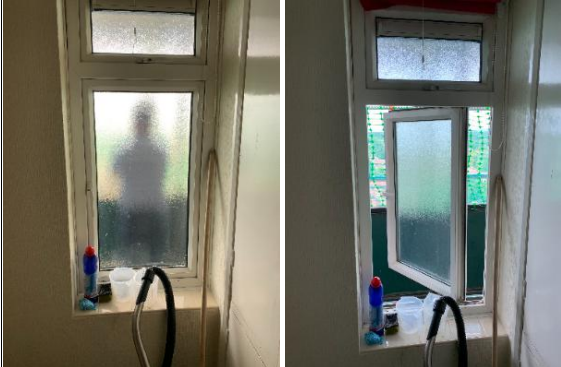
8.6	The layout of flats is such that by normal means residents would have to pass from their bedroom through the living room and past the kitchen to reach the flat entrance door. An alternative has been provided in the bathroom, where escape windows have been installed. This alternative provides a means by which, from a bedroom, the resident could enter the bathroom and use the escape window as opposed to passing through the living room and by the kitchen.

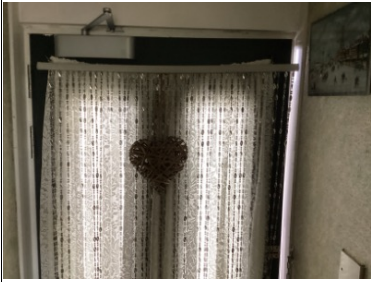
9.1, 9.5, 9.8	The top of the doorframe should be fire-stopped to the same level of fire resistance as the surrounding construction.
	Observation
9.1, 9.5, 9.8	<p>It was observed at the time of the fire risk assessment that the door to flat 60 did not close fully in the frame unaided. Where fire doors are not able to self-close fully into the doorframe, fire and products of combustion may be able to spread from the compartment of origin and onto the escape route.</p>

9.1, 9.5, 9.8	It is recommended that either the door/self closer be adjusted so that it is able to self-close fully into the doorframe unaided.

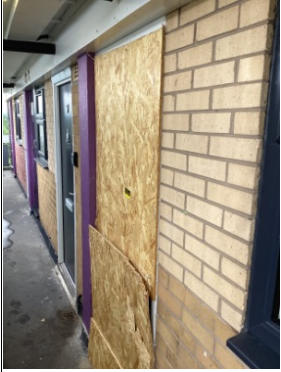
Observation	
9.1, 9.5, 9.8	<p>At the time of the fire risk assessment, wooden panelling was observed on the 8th floor adjacent to flat 71 either covering a defective window or door. The wooden panel may not provide the necessary level of fire resistance and due to there being no 1.1m gap for residents to escape under, in the event of a fire, the residents may not be able to evacuate, placing them at risk of harm.</p>

Recommended Actions	
9.1, 9.5, 9.8	<p>It is recommended that the wooden panelling be removed, and the door/window that is covering it be repaired.</p>

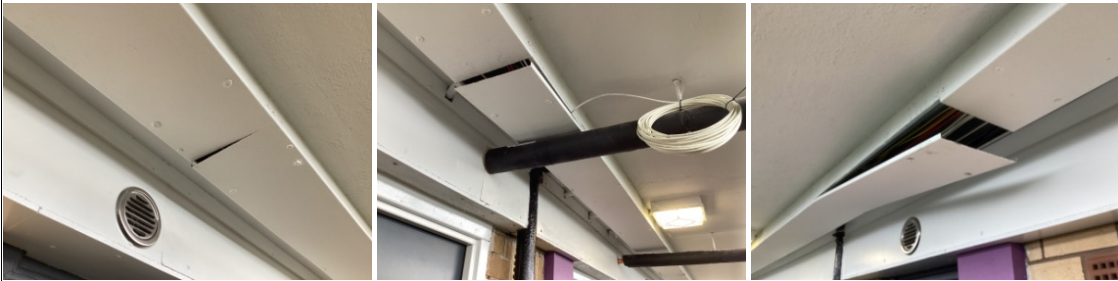
Ref	RECOMMENDATIONS
	Observation
9.1, 9.8	<p>At the time of the fire risk assessment, it was observed that the metal trunking was open outside;</p> <ul style="list-style-type: none"> • Flat 8 • Flat 21 • Flat 22 • Flat 26 • Flat 34

9.1, 9.8	The metal trunking should be closed and secured to prevent access and tampering.
	Observation
9.5	The kitchen door was wedged open at the time of the fire risk assessment.

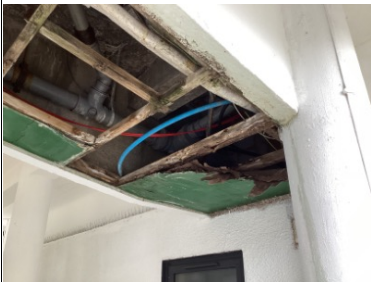
9.17-9.18	<p>It was observed at the time of the fire risk assessment that there was a breach in the ceiling above the side exit (with the padlocked gate). This leaves the building exposed to external fires and arson as the internal structure of the building is exposed. Due to this being a type 3 non-invasive assessment, there is potential that there could be breaches within the structure of the premises that would allow a fire to spread throughout.</p>

9.17-9.18	It is recommended that the ceiling be repaired.

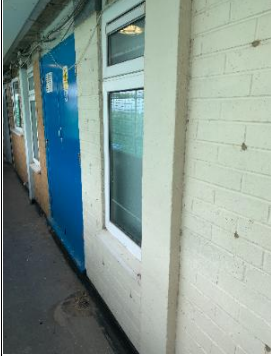
Ref	COMMENTARY
9.1	<p>The bathroom windows from residential flats are non-fire resisting and are not fixed, with them opening below a height of 1.1m. Although non-fire resisting and non-fixed windows are not usually accepted on single-direction open decks below a height of 1.1m, this arrangement has been accepted due to:</p> <ul style="list-style-type: none"> • Sprinklers are installed throughout each residential flat. • The common monitored fire alarm system extends into the flats. • The bathrooms are low-risk rooms in which it is very unlikely a fire would begin.

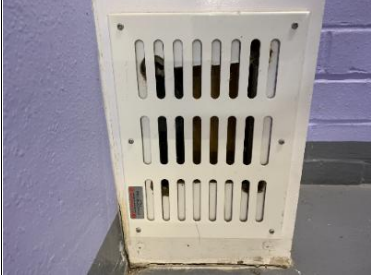
9.1	<p>There is a boxed-in section of conduit/trunking which runs the full height of the stairs, in the corner of each landing. This has vents cut into it, but its purpose could not be determined. However, the stairs are well ventilated and the vents are covered with intumescent grills. These arrangements were found to be acceptable to our consultant.</p>

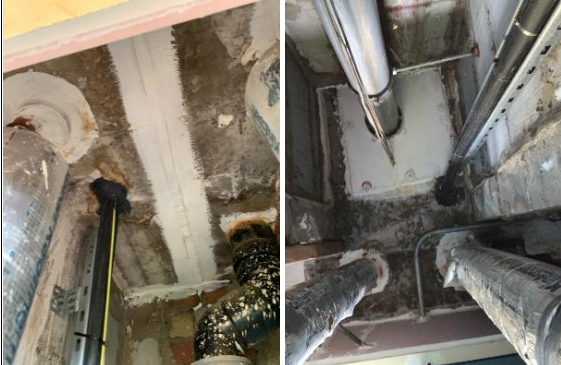
9.1, 9.8	<p>It has been highlighted in previous Fire Risk Assessments that compartmentation works have been carried out throughout the premises by Allied Protection Ltd (circa July 2017). They are an accredited passive fire protection contractor and they have provided WCHG with documentary/photographic evidence of their work. Following the installation of the common fire alarm system, further fire-stopping was required. This was carried out by Flame Hold Ltd, another accredited passive fire protection contractor who has also provided WCHG with documentary/photographic evidence of their work. Additionally, it was noted during the course of this FRA that remedial fire stopping and compartmentation works have been carried out by Alpha Fire Solutions, accredited contractors (during April 2022) following the installation of the sprinklers and new flat entrance doors. It is indicated by labelling that the extent of the fire-stopping works incorporates spaces such as behind sprinkler trunking, however, this was not confirmed due to this fire risk assessment being non-destructive. Note: WCHG has implemented annual compartmentation inspections by an accredited passive fire protection contractor.</p>

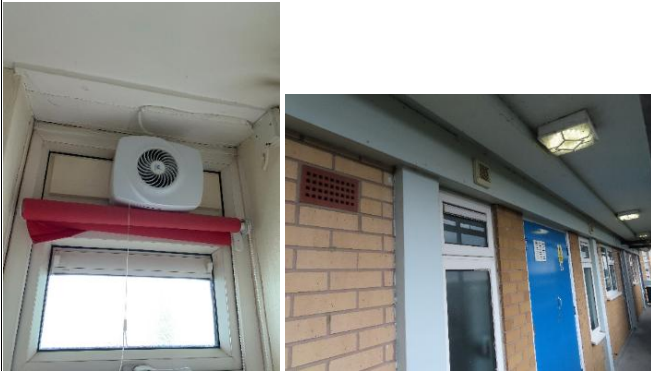
9.11	<p>Kitchen/Bathroom Extraction:</p> <p>It was noted that the kitchen and bathroom ventilation in the flats seen is extracted directly to the outside via powered fans installed within the walls above the windows of the flats and which were not common to any other flats. The extraction was at a height of above 1.1m. It is reasonable to assume that all the flats in the block have similar provisions installed.</p>

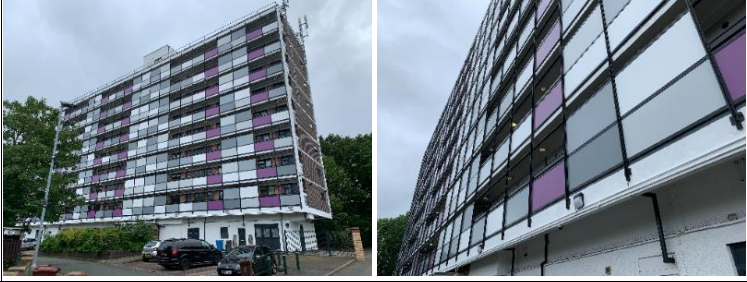
9.18	CCTV equipment was observed in the common areas
9.27-9.29	<p>WCHG has confirmed that works have been commissioned for both the balcony panels and the spandrel panels to be replaced. WCHG provided the previous assessor with information and relevant certification showing that the materials are to be replaced with the following:</p> <p>Window spandrels - Replaced with 'Proteus SP' material produced by 'Proteus Facades'. This is a polyester powder-coated steel/ceramic powder-coated aluminium/glass-faced spandrel panel with a Rockwool insulated core structurally bonded to a lightweight metal rear skin to be used within a curtain wall system. Warrington Fire Testing and Certification Limited have classified the material in relation to their reaction to fire behaviour as A2, S1, d0.</p> <p>Balcony panel - Replaced with '3mm aluminium panels coated on both sides'.</p> <p>Work to identify the unsuitability of the panels and spandrels was detailed in a report carried out by Tenos fire engineers for a similar building and this information has also been applied to this site.</p>

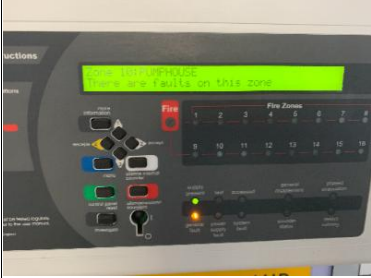
10.0 Automatic Fire Detection: Finding(s)	
Ref	SIGNIFICANT FINDINGS
	Observation
10.1	<p>The fire alarm panel in the residential ground floor lift lobby was showing a fault in the pump house at the time of the assessment. Where the fire alarm system is not fully functional, a fire which would otherwise be communicated to the monitoring centre would not be, enabling development and potentially placing persons at risk of harm.</p> <p>Note: There is evidence that WCHG have completed this action, however, there seems to be an issue with the panel.</p>

Recommended Actions
10.1	A competent person should attend the premises to carry out remedial works in order to ensure the fire alarm system is fully operational. Investigations should be made into why the fault is reoccurring.
Ref	RECOMMENDATIONS
	None.

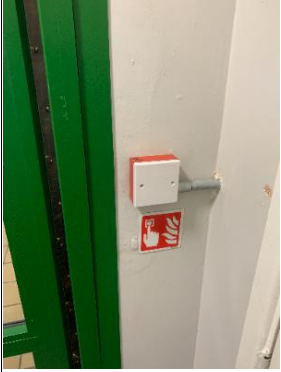
10.3	WCHG have confirmed that all alarms are checked and the findings recorded as part of the annual gas servicing.
10.9	<p data-bbox="236 976 1495 1059">The previous fire risk assessment recommended that the manual call points by the main entrance door and laundry be removed from use in order to reduce the potential for false activation. At the time of the fire risk assessment, it was observed that the manual call points in these areas had been capped off so that they are not able to be used.</p>

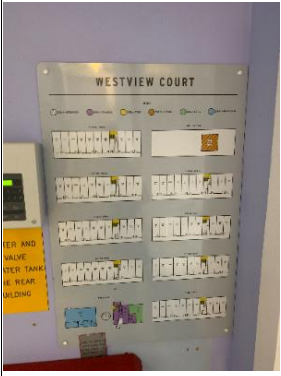
10.13	<p data-bbox="236 1451 1495 1509">A suitable zone plan was observed by the common fire alarm panel in the ground floor lift lobby, which also displayed the building layout.</p>

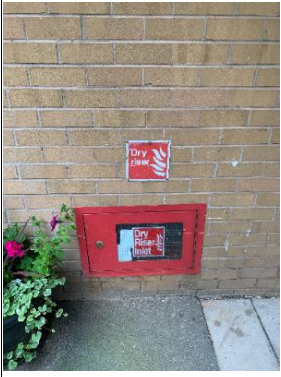
12.6-12.8	<p>A dry-rising main is installed for use by the Fire and Rescue Service. The dry-rising main outlets are located on each level of the staircase and are behind locked doors. The inlet is located adjacent to the main entrance, on the external façade. The dry rising main is visually inspected annually and is also serviced annually, with 6-month periods in between each of these inspections/services.</p>

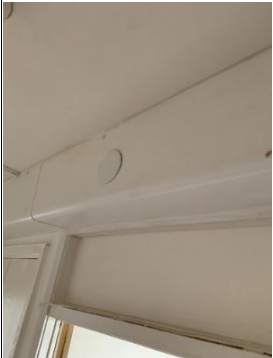
12.8-12.10	<p>A BS9251 sprinkler system has been installed. In each flat, there are concealed sprinkler heads located in the hallway, bedroom, the living room, and the kitchen (essentially all rooms except the bathroom). In addition, there are also sprinkler heads located in the ground floor laundry and community room. A pump and water tank for the sprinkler system has been provided. The system is maintained and serviced by an approved contractor on an annual basis, with records to evidence this practice held centrally by WCHG.</p>

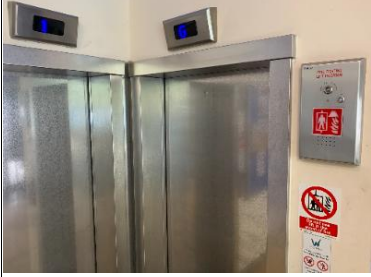
12.10-12.11	<p>One of the lifts on the premises appears to be a standard passenger lift, whereas the other appears to be a firefighting lift. The firefighting lift has a switch to return the lift to the ground floor level and also an intercom for communications. Within the lift was a hatch in the ceiling. It was confirmed to our assessor that the lift defaults to the ground floor on activation of the common fire alarm system and that the switch to manually return the lift to the ground floor is tested monthly in line with the Fire Safety (England) Regulations 2022. Records to evidence such testing are held centrally by WCHG. It was communicated that all keys required for the operation of the lift have been provided to the Fire and Rescue Service and are also held in the SIB. It was also communicated that the firefighting lift could continue to be used by firefighters without having to reset the alarm if sounding audibly.</p>

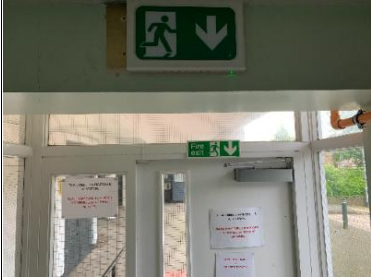
Ref	SIGNIFICANT FINDINGS
	Observation
13.6	<p>No fire action notice is provided in the community room, instructing persons of the action to take in the event of a fire. Where persons are not provided with such instruction they may take incorrect action in the event of a fire, placing persons at risk of harm.</p>

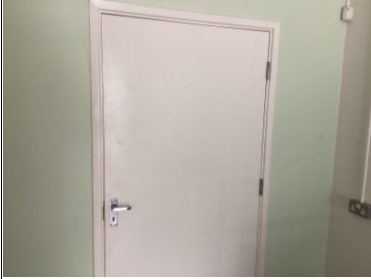
13.10	<p>It was observed that there was no 'FIRE DOOR KEEP LOCKED' signage installed in the storage room within the community room. Lack of signage may result in this door being left open, and allow for the passage of fire or products of combustion, placing persons at risk of harm.</p>

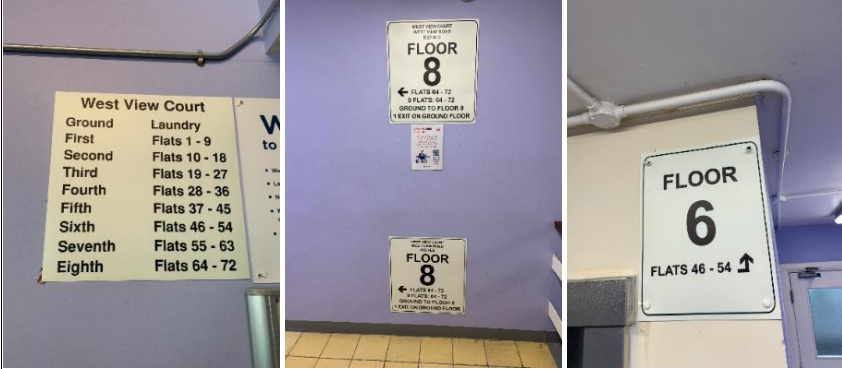
13.15	Wayfinding signage was observed on the staircase landings and on the open decks which indicated the floor level and the flats on that floor. Such signage was also observed in the lift lobby at ground floor level.

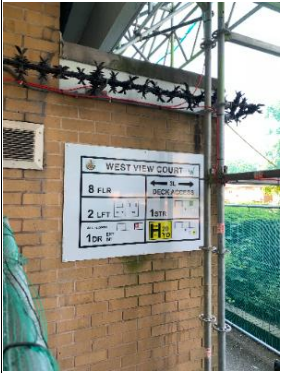
14.11	The previous fire risk assessment confirmed that the Fire Service has been provided with access fobs for all WCHG high-rise blocks.
14.11	Signage indicating certain provisions of the building is displayed externally, which may be used to assist attending Fire and Rescue Service personnel. (Photo used from previous fire risk assessment).
